Annual Monitoring Report of First year

Monitoring of environment parameters and implementation of Environmental Management Plan during pre-construction and construction period along with Engineering Activities for site development of Khulna 1320 MW Coal based Thermal Power Plant

Annual Monitoring Report of First year
Monitoring Period: February 2014 – February 2015
Combined Report of Monitoring in Four Quarters

**Bangladesh – India Friendship Power Company
(Pvt.) Limited**
(A joint Venture of NTPC Ltd and BPDB)

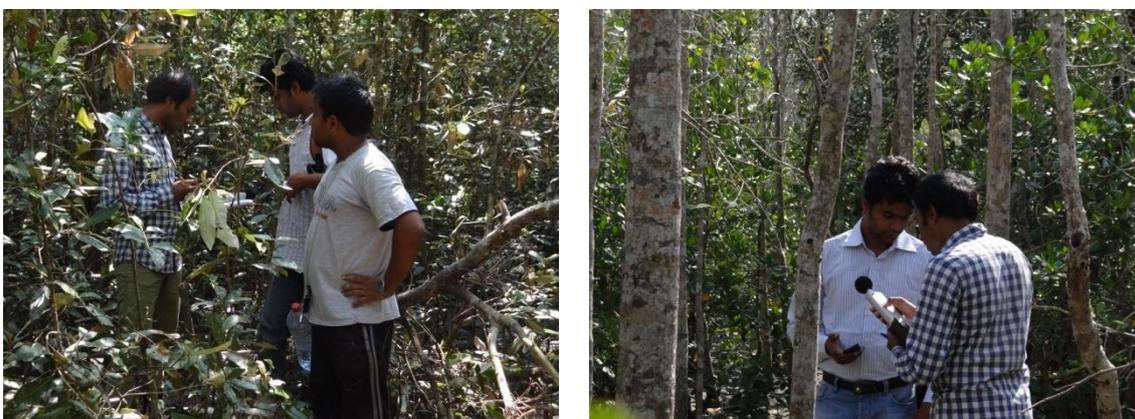
Photo 4.1: Specialists calibrating and setting up noise meter at site before use

24. Noise levels were measured for thrice in a day (morning, afternoon and evening) in each of the 11 locations selected for noise monitoring. Each time noise level was recorded for a five minutes time span with a 30 second interval by using portable noise level meter. Depending on the site condition and acoustic environment, the noise meter was set up and calibrated each time following the manufacturer's instruction manual.

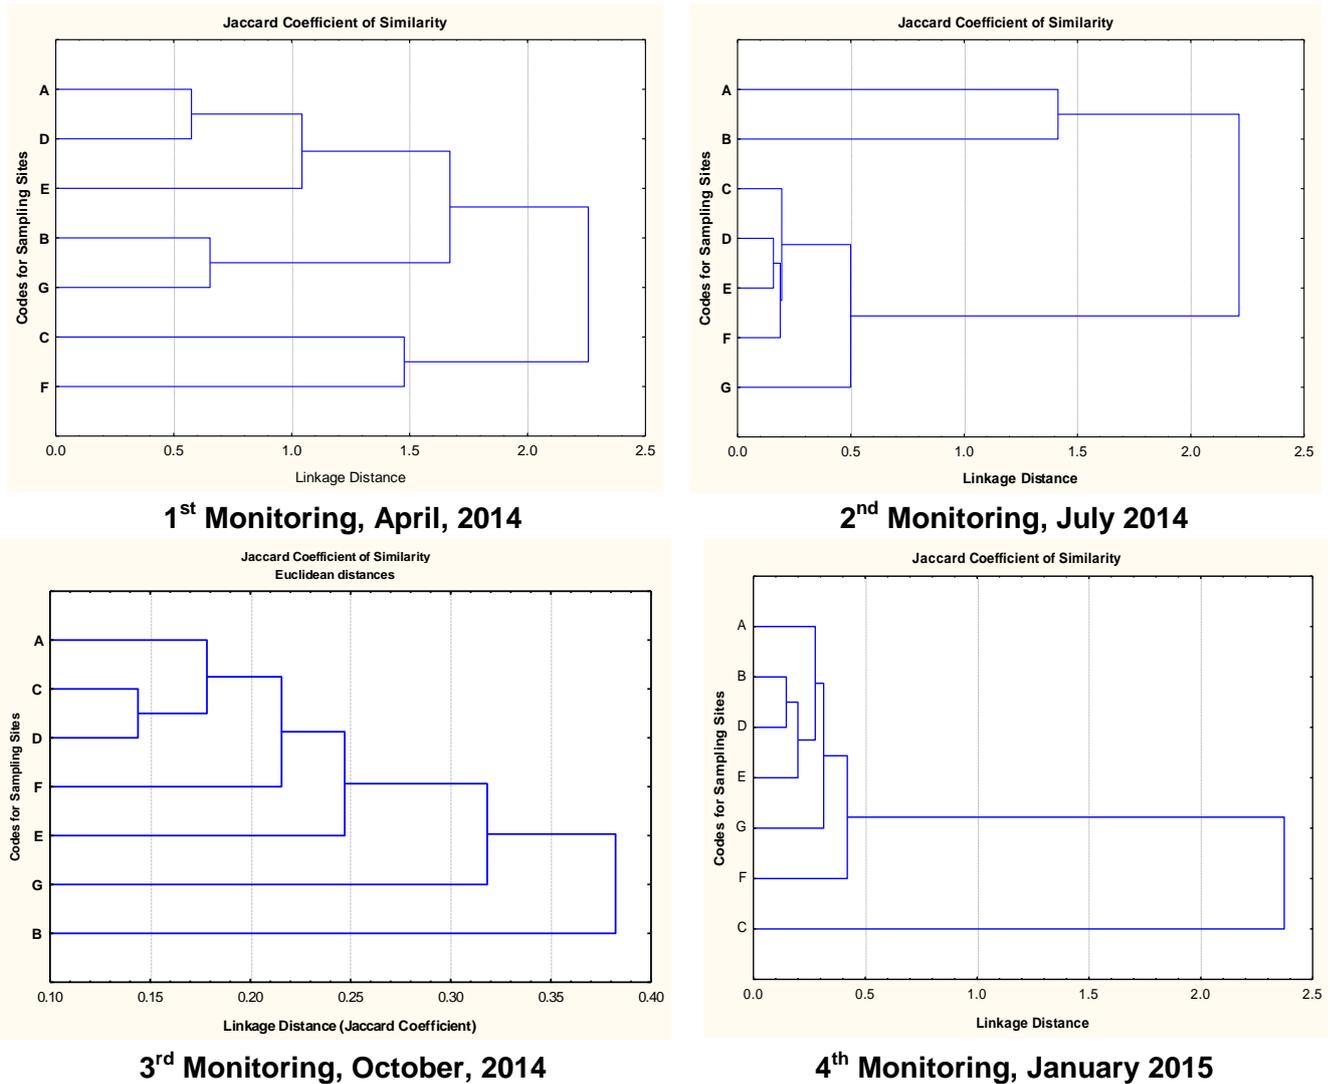
**Figure 9.2: Dendrogram Showing Similarity in Binary Species Composition in seven sampling sites
(b) Habitat Suitability Index (HSI)**

134. This figure analyses the distances among the JI (Jaccard Coefficient Index) indices which are opposite to the JI values. The length-wise distribution relationship among the sampling sites was found different during third, second and first quarter monitorings. For example, the JI value between site A and D was the highest in the first monitoring but in second monitoring this value became highest between D and E sites. In third quarter monitoring highest JI value was found between C and D sampling sites. On the other hand, the JI value between B and D sampling sites was the highest in fourth monitoring phase in the month of January, 2015. Because, different length group of different fish species use their habitat for their morphological and physiological suitability in respect of food coverage, water quality and reproductive performance. It has also been found that the length frequency of different fish species were more homogeneously distributed among the sampling sites in case of third quarter monitoring phase in the month of October than that of first and second quarter monitoring (**Figure 9.2**).

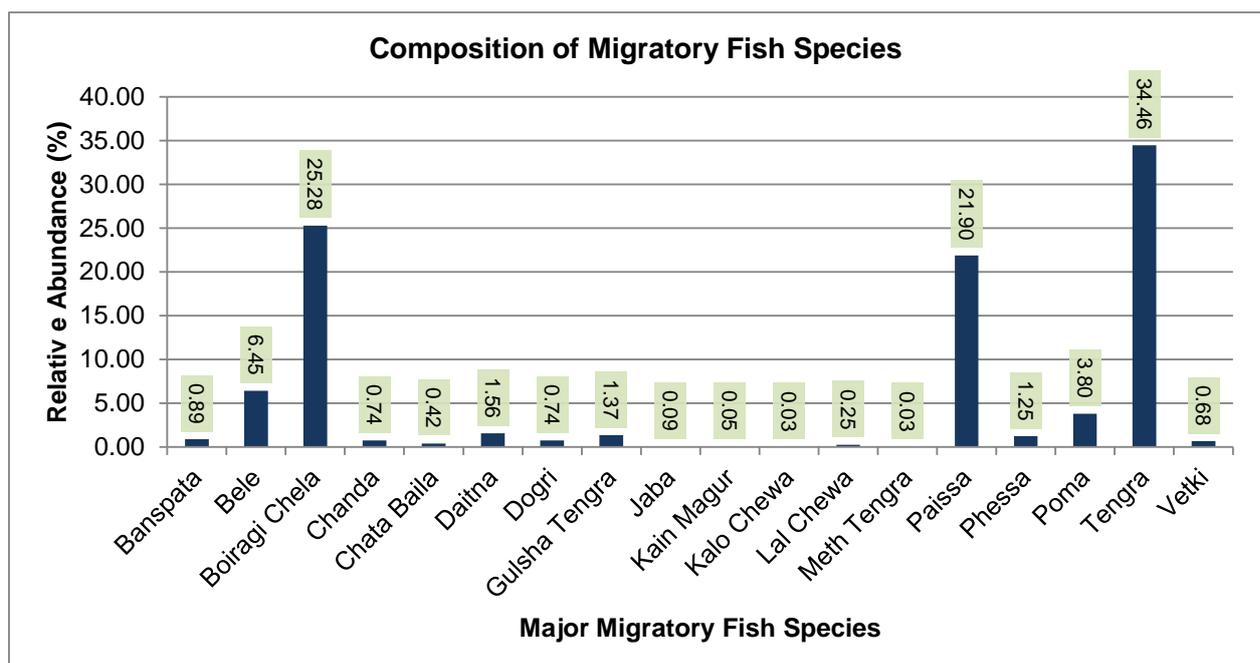
Figure 9.5: Relative abundance of migratory fish species in sampling sites

141. Migratory species have been identified by analyzing the common species available in the regular catch from the sampling sites. Fish species like Boiragi Chela, Paissa and Gang Tengra attain the maximum abundance among the migratory fish species observed in fourth monitoring phase. The availability of all other species was very low as compare as found in other monitoring phases. The relative abundance of the migratory species is give below in the **figure 9.5**.

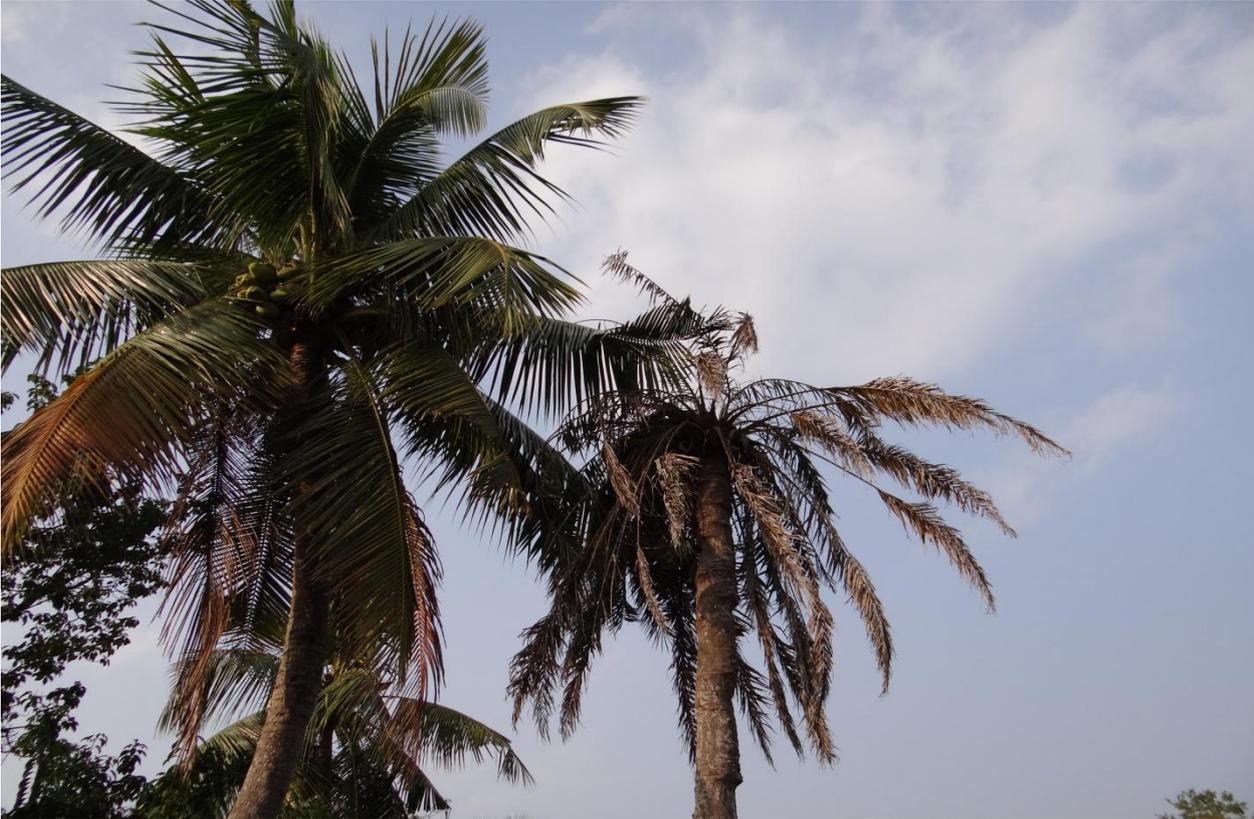
Photo 10.2: Unhealthy coconut and date palm plant at studied homesteads in Chalkghona.

symptoms. Leaf spot and spot canker on fruits is the common symptoms of *Cocos nucifera*. In addition, diameter loss at top portion of this monocot is also common symptom of this plant in all location. Infection of fungal disease is not remarkable all the homesteads.

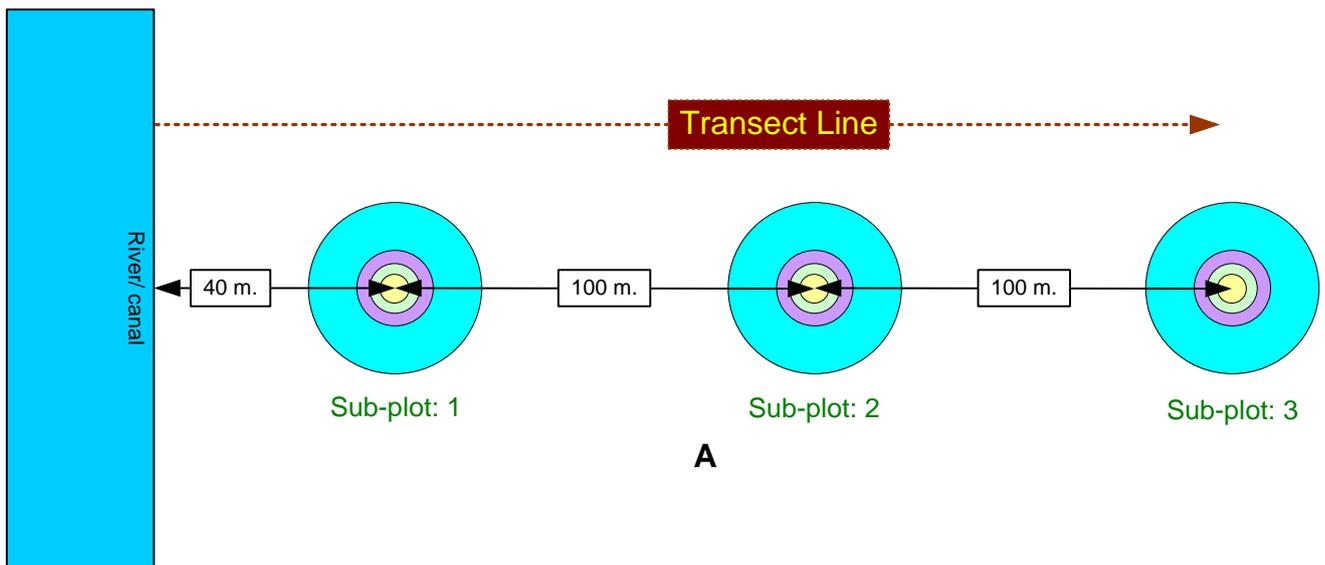
Figure 11.1: Layout of the subplots and transect line perpendicular from ecotone (river or canal bank)

165. In each site, a transect line was laid out perpendicular to river or canal bank. Along, the transect line three circular nested subplots of 12.62 m radius were laid out at 100 m intervals in order to capture maximum tree species (Figure 11.2). Because of variation of species composition in SRF observation plots were laid out from coast, river or canal side to landward zone (forest proper side). The location of the first subplot was 40 m away from ecotone (riverside) to inner ward of forest in order to save the subplot from river bank erosion.

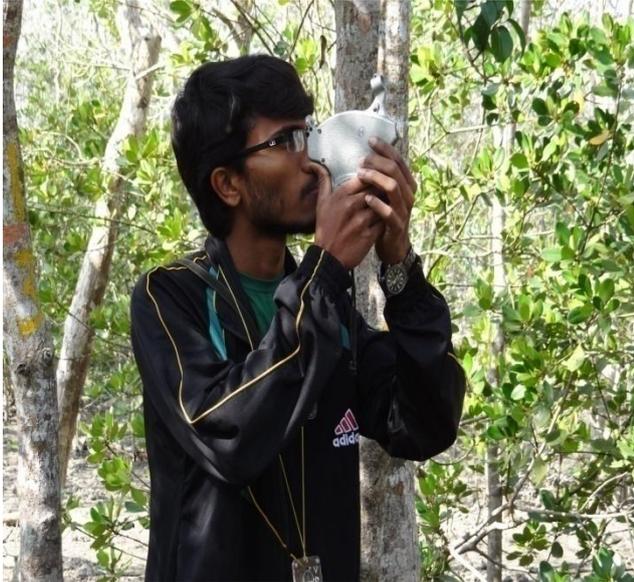
Photo 11.1: Surveyor measuring tree height using Hoga Altimeter in January 2015 monitoring

The diameter of all trees was measured at breast height (1.37 m) and height was measured using Hoga Altimeter (Photo. 11.1) measured. Also, tree living status, damage and disease (top dying, canker) condition were also observed.

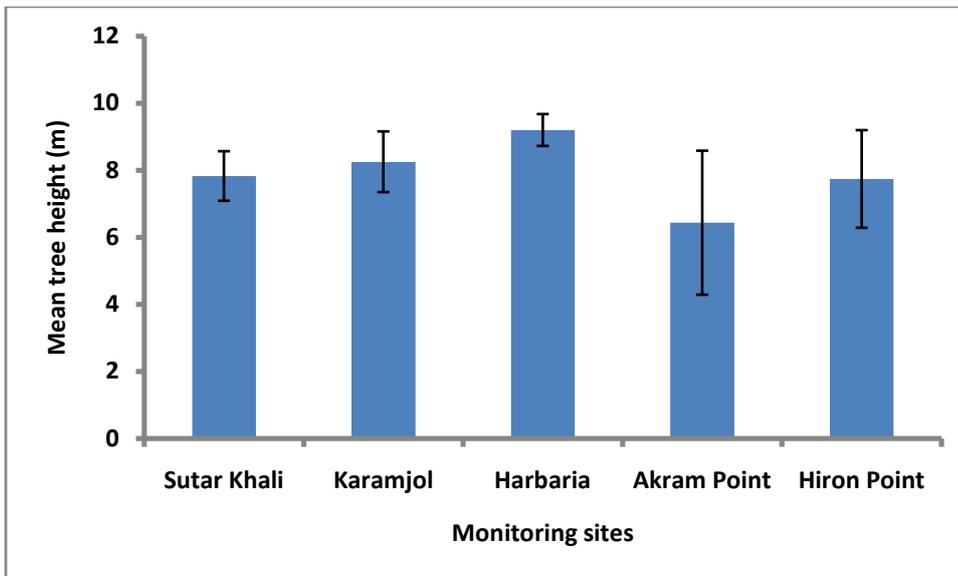
Figure 11.3: Mean (\pm 95% CI) tree height in fourth quarter suervey in five monitoring sites of the SRF.

176. In the current monitoring, firstly the height was measured. The mean tree height in Sutarkhali, Karamjal and Hiron Point was similar. In herbaria, site tree height was highest, while it was lowest in Akram point.

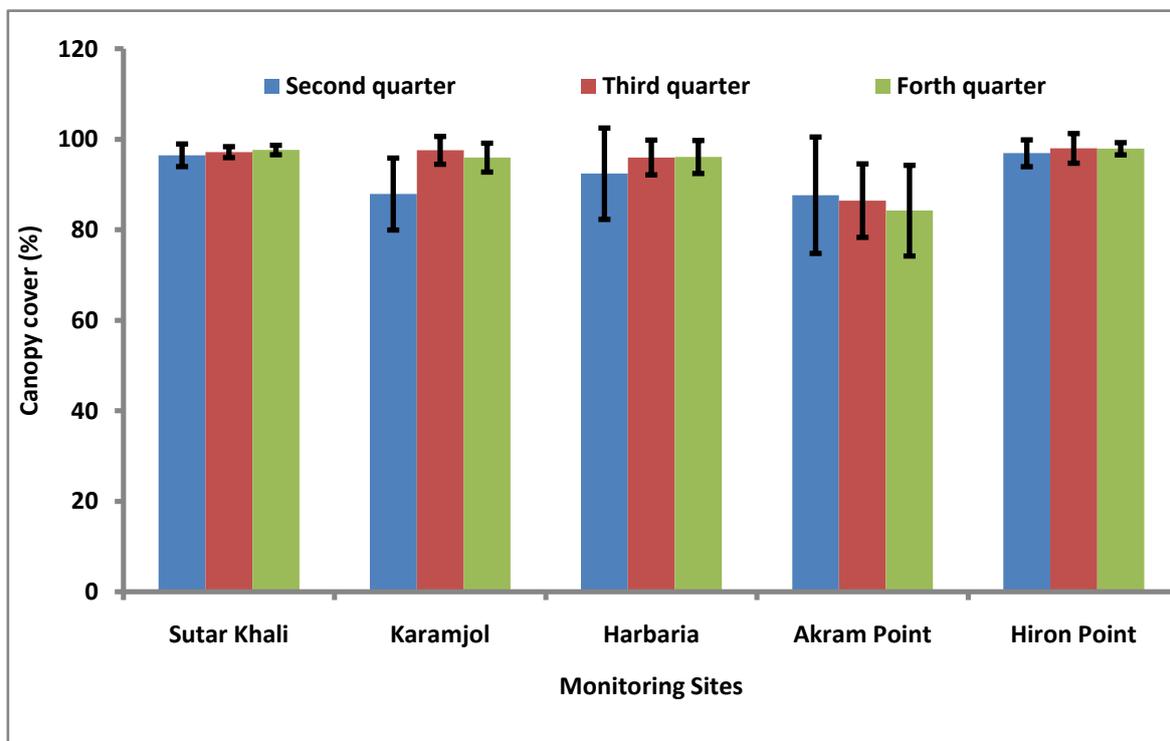
Figure 11.4: Mean (\pm 95% CI) canopy cover (%) between first and second quarter suervey in five monitoring sites of the SRF.

177. The canopy cover percentage in the five monitoring sites was not significantly varied during the three monitoring periods ($P < 0.05$; Figure 11.4). These findings indicate that the foliage heath condition across the five monitoring sites was good with no or less insect damage.

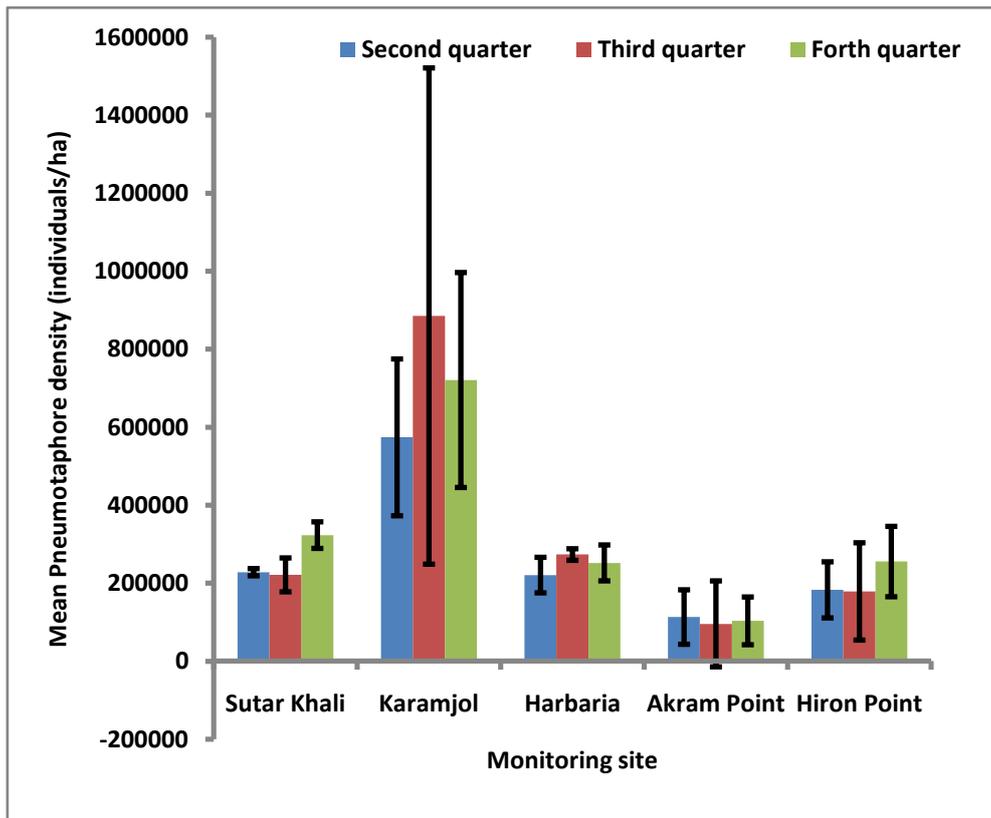
Figure 11.5: Average (\pm 95% CI) number of pneumatophores density among the quarter suervy in five monitoring sites of the SRF.

178. The mean density of pneumatophores was varied significantly in Sutarkhali monitoring site ($P < 0.05$). This was because it is a Sundori dominated stand where new pneumatophores grow up the course of time. However, no significant difference was found in pneumatophores density of the four other monitoring sites ($P > 0.05$). A similar trend was found at Harbaria, and Akram point site, while in Karamjal and Hiron Point, though it was observed decrease and increase trend in Pneumatophores density, in ANOVA analysis, these change were not significant during the three time periods. This could be due to the large variation among the subplot (replication). As for example, in the third subplot in Karamjal site mainly dominated by Baen tree and it has numerous tender pneumatophores that usually dry up and die during dry season.

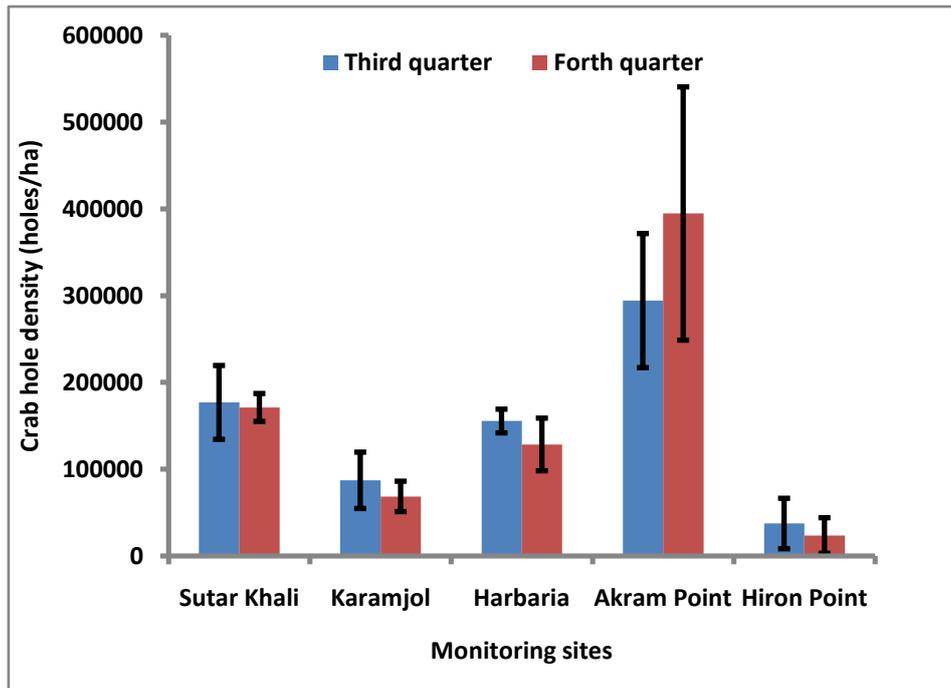
Figure 11.6: Mean (\pm 95% CI) crab hole density between first and second quarter survey in five monitoring sites of the SRF.

179. According to paired t-test analysis, the crab hole density was not varied between the second and fourth quarter monitoring in the five monitoring sites- Sutarkhali, Harbaria, Karamjal, Akram Point and Hiron Point ($P > 0.05$; figure 11.6). In the all the all the sites (except Akram point), the crab hole density decrease from the third quarter monitoring. As the crab density is related to water availability that means regular inundation, the fourth quarter monitoring that was conducted during the dry season, experienced with lower crab density.

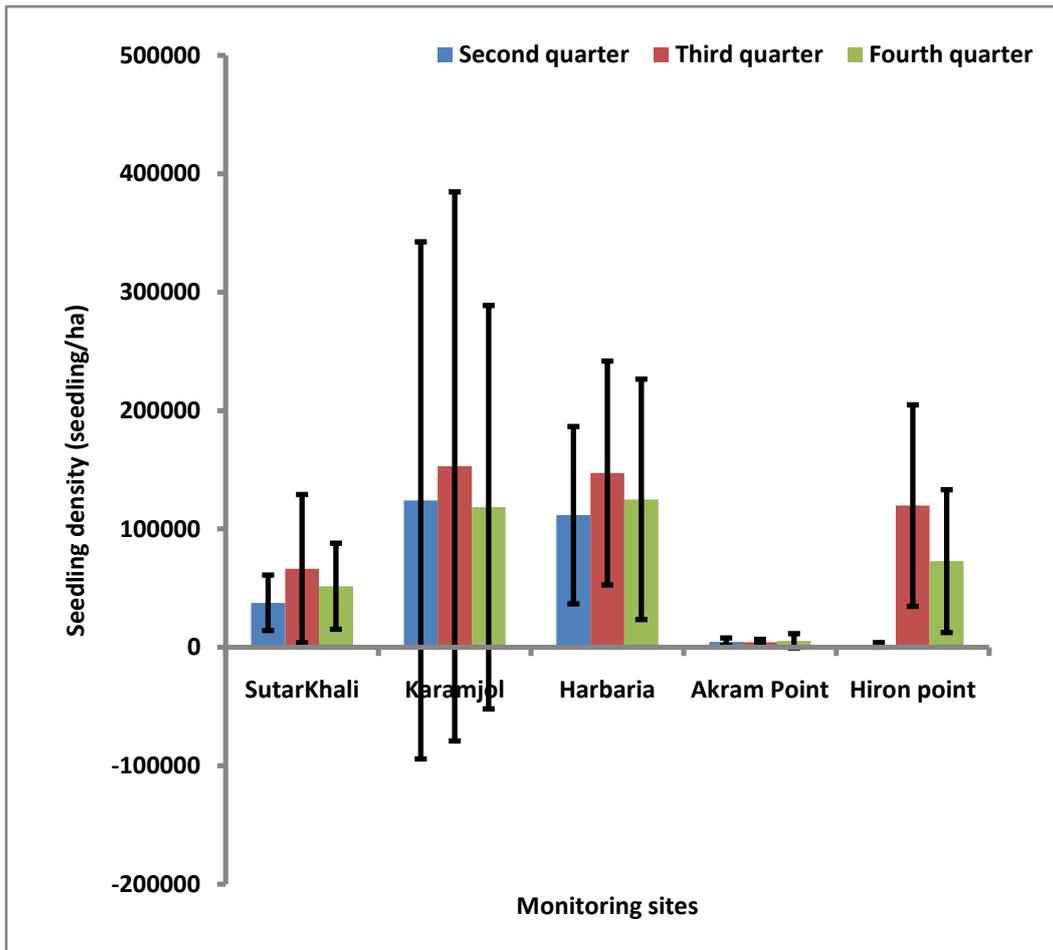
Figure 11.7: Mean (\pm 95% CI) seedlings density among second, third and fourth quarter survey in five monitoring sites of the SRF.

180. The seedlings density across the five monitoring sites was not significantly varied in ANOVA analysis ($P > 0.05$; Figure. 11.8). However, a decreasing trend of seedling recruitment was found in all sites except Akram Point (Table 11.2). This declination of seedling density is due to natural motility of seedling which is a common in mangrove at the early stage of seedling development.

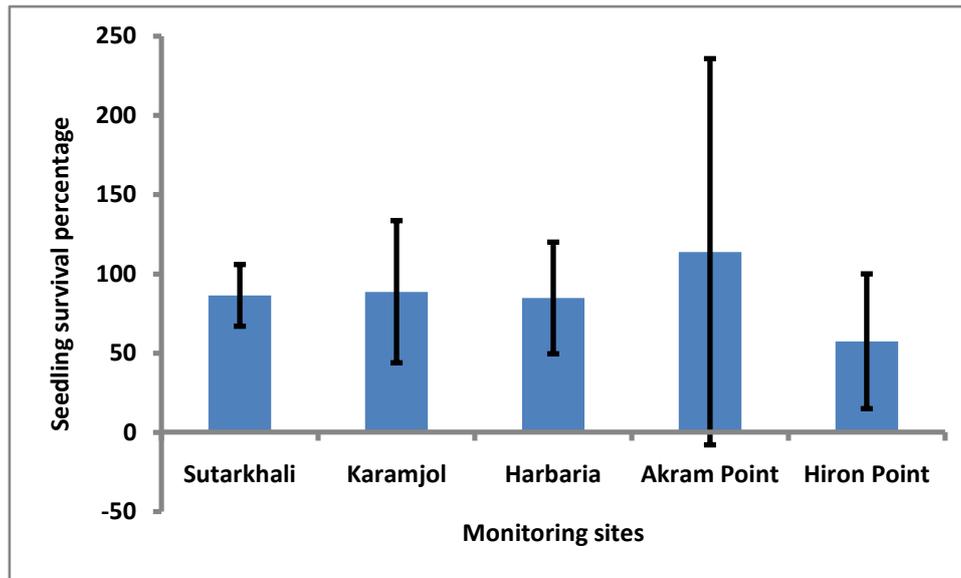
Figure 11.8: Mean (\pm 95 % CI) seedling survival percentage between third and fourth quarter survey in five monitoring sites of the SRF.

181. The seedlings survival percentage that were calculate from number of live seedlings present from the third quarter to fourth quarter monitoring across the five monitoring sites. The percentage of seedlings survival was found similar in Sutarkhali, Karamjal and Harbaria monitoring sites. In Akram point site, the survival percentage of seedling attained higher because during this time interval new seedling appeared in the fourth quarter monitoring, while in Hiron Point seedling survival percentage was lower (Figure 11.8).
